# DRAFT FERNAN LAKE WATERSHED MANAGEMENT PLAN

Prepared by  
Fernan Lake Watershed Technical Advisory Committee

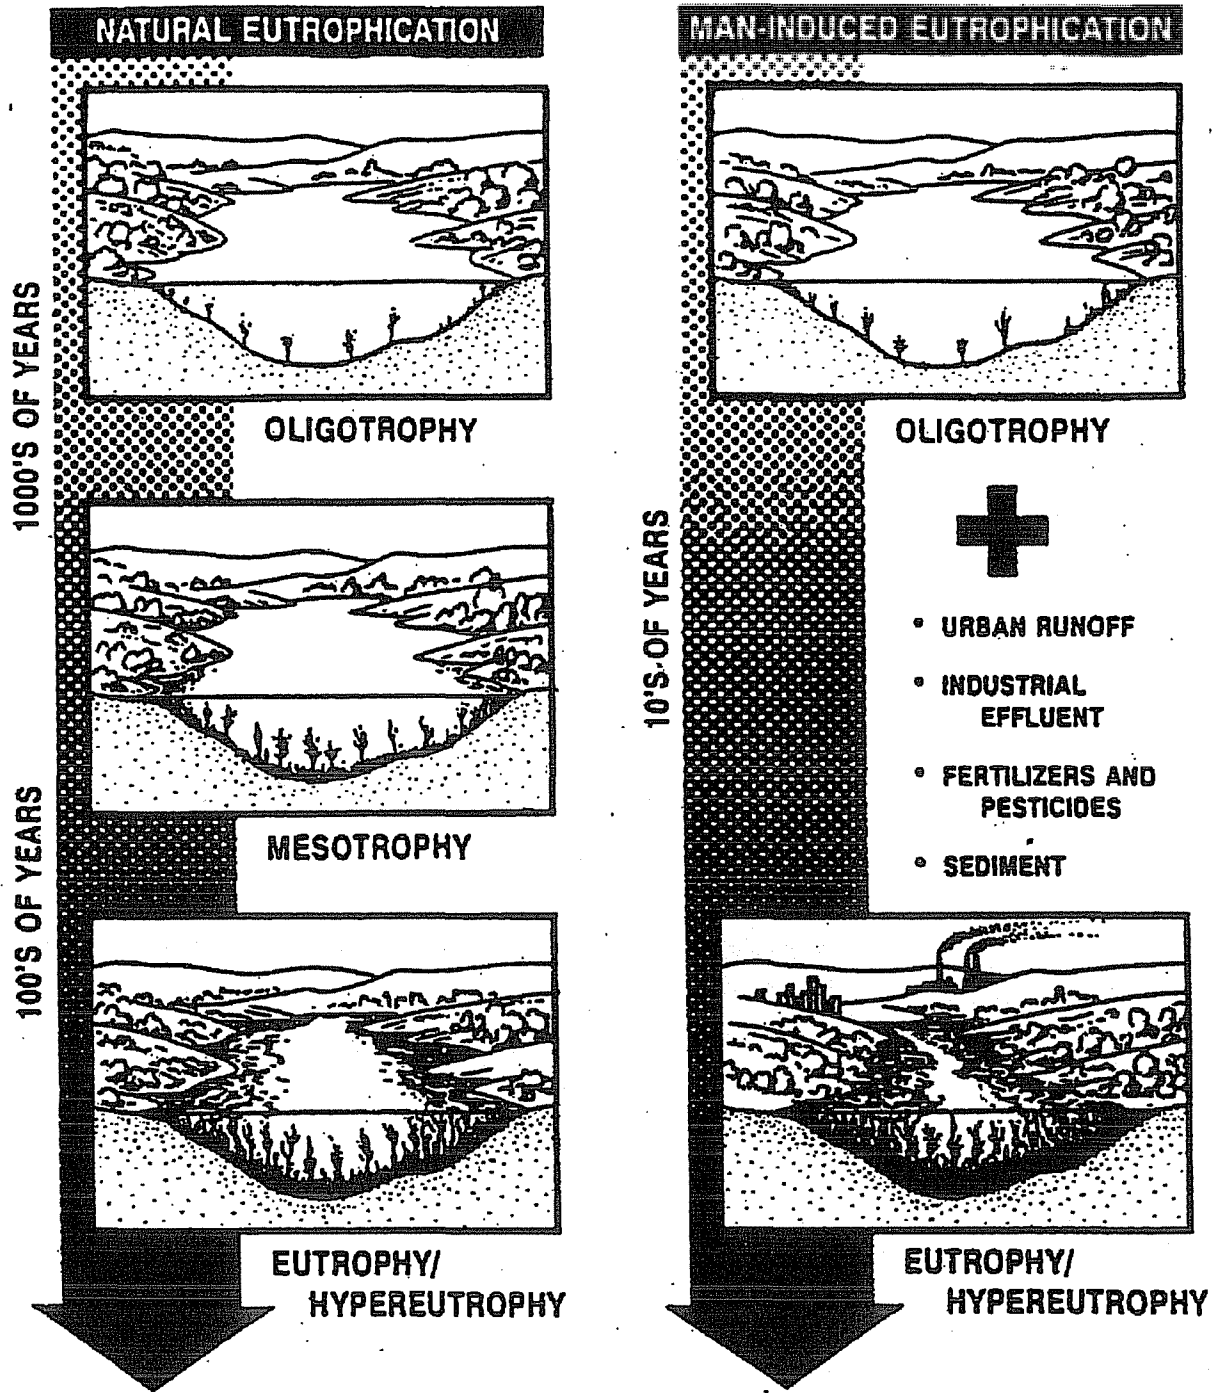
Eutrophication is the progression of natural lake aging through nutrient-poor (oligotrophic) to nutrient-rich (eutrophic) stages (Figure 2). Hypereutrophy represents extreme productivity characterized by algal blooms or dense macrophyte populations (or both) plus a high level of sedimentation. Figure 2 depicts the natural process of gradual nutrient enrichment and basins filling over a long period of time (e.g. thousands of years). Human-induced or cultural eutrophication is a process in which lake aging is greatly accelerated by increased inputs of nutrients and sediments into a lake, as a result of watershed disturbance (EPA, 1990). Limnologists have developed various classification schemes to place lakes in a "trophic" state category. Two classifications are listed below (Table 3) which use ranges of three measured parameters to define trophic state. The three measurements are: in-lake total phosphorus concentrations, phytoplankton biomass as represented by chlorophyll a concentrations, and water clarity as measured by visibility depth of a Secchi disc.

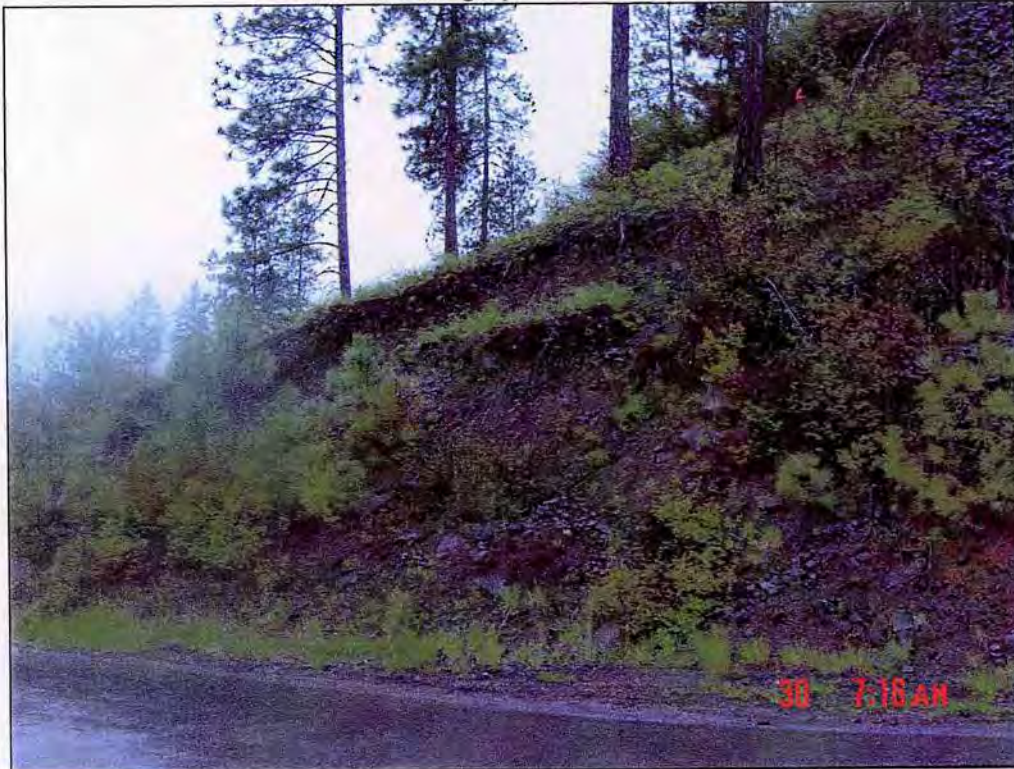
Figure 4. Photo Showing Typical GTU 1 Terrain – Fernan Hill Terrace Area

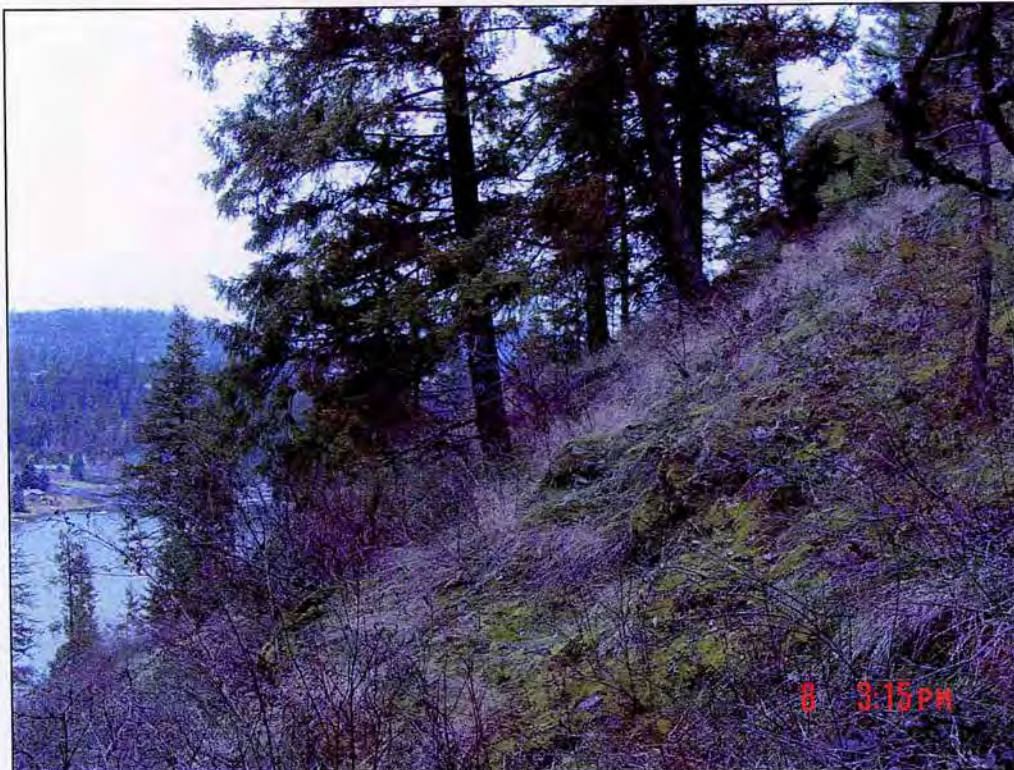
Figure 5. Photo Showing Typical GTU 1 Terrain – South Shore Fernan Lake

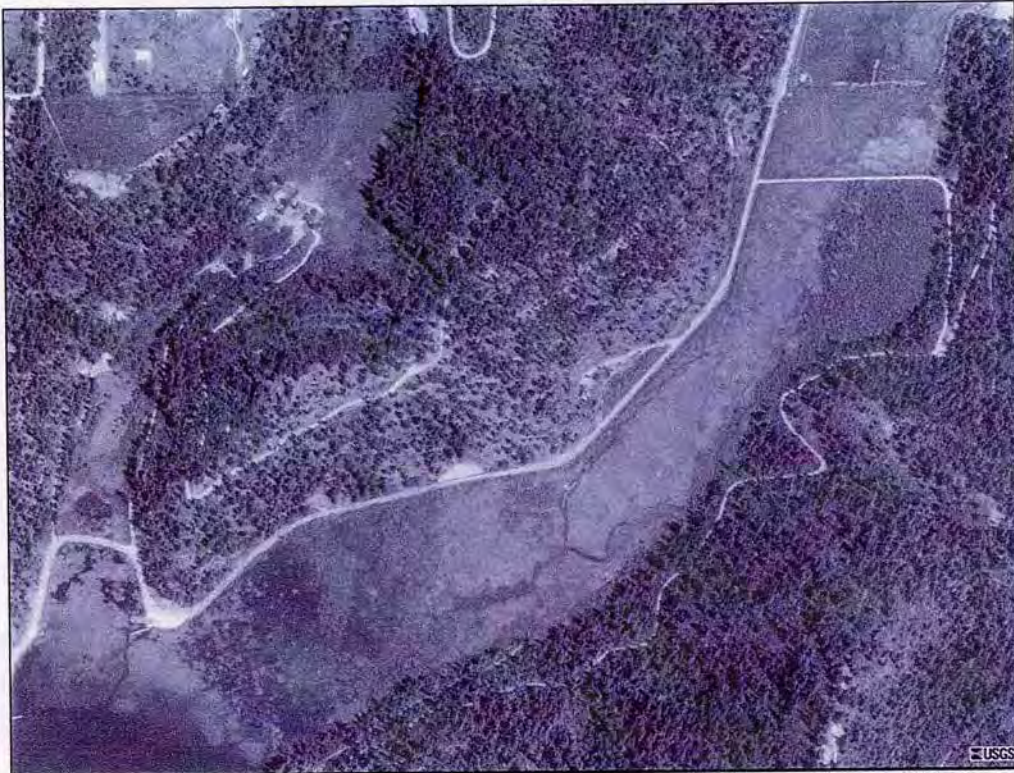
Figure 6. Air Photo of Typical GTU 2 surrounded by GTU 1. – Mouth of Fernan Creek

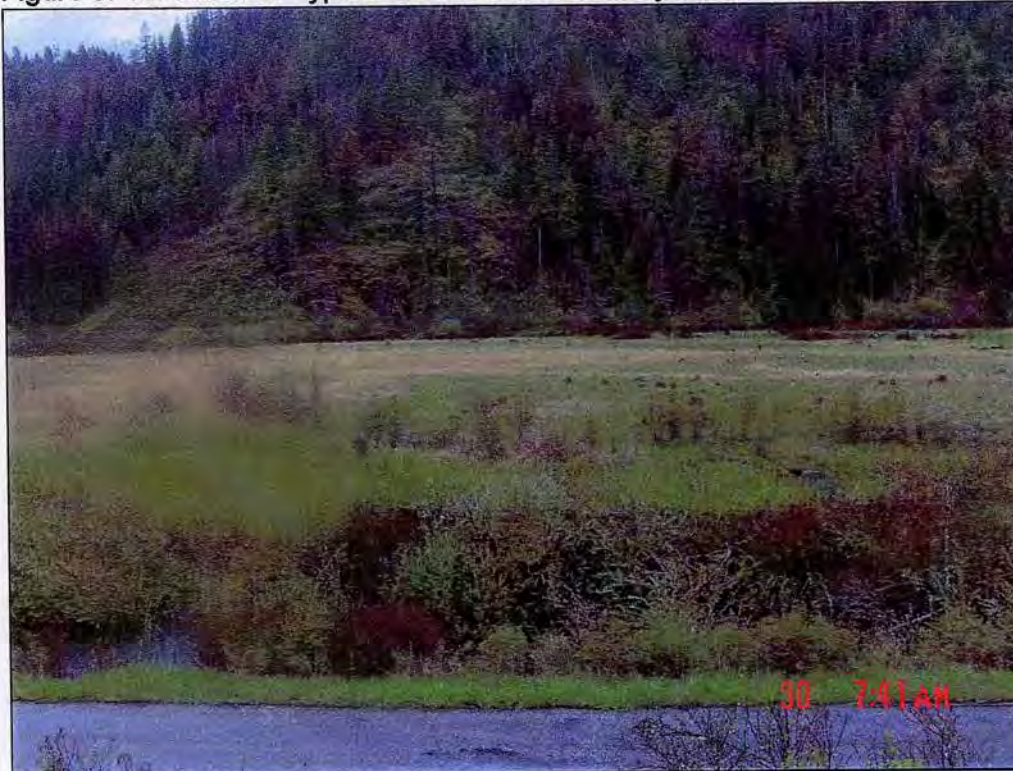
Figure 7. Photo showing Typical GTU 2 Conditions (foreground). – Fernan Creek Area

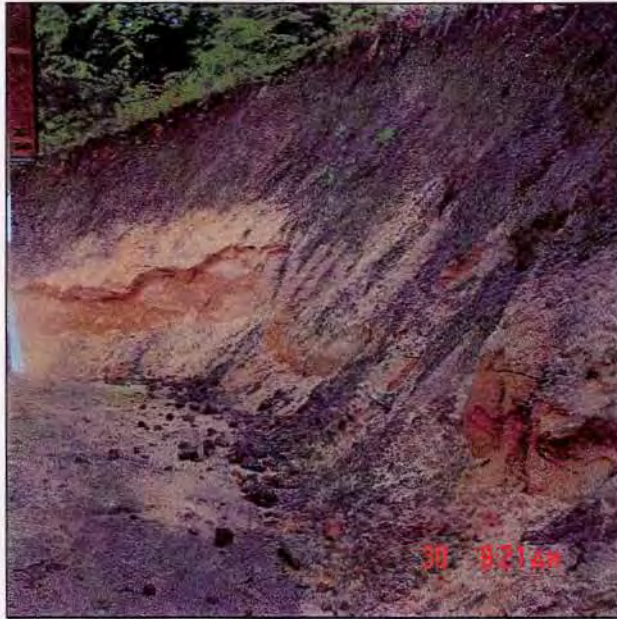
Figure 8. Photo showing Typical GTU 3 Conditions – Armstrong Park Area

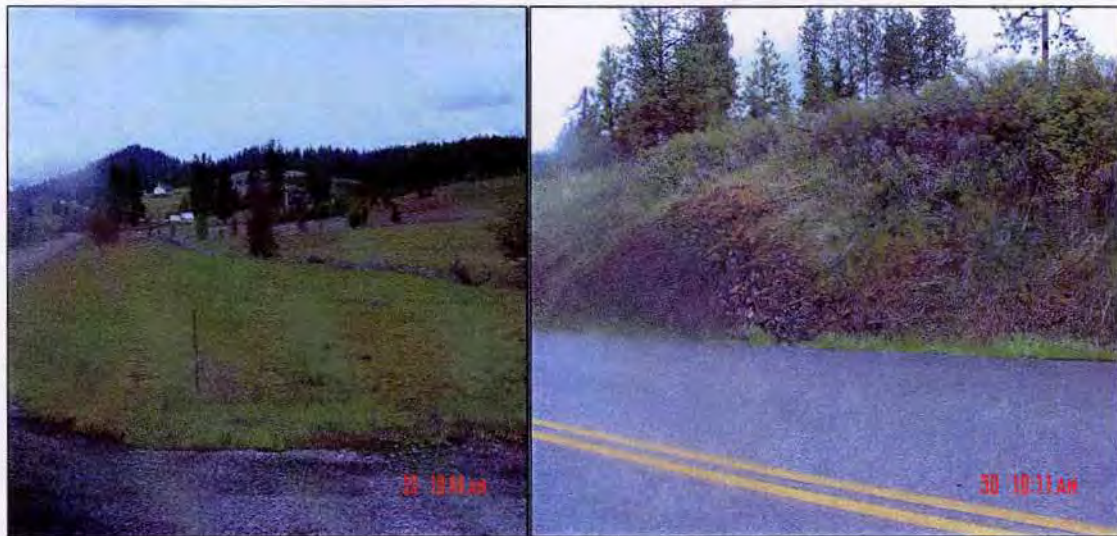
Figure 9. Photo showing Typical GTU 3 Conditions – French Gulch Area
